# ***AAIB Bulletin***

# ***1/2023***

## ACCIDENT

| <b>Aircraft Type and Registration:</b> | Freefly Systems Inc. Alta X | |

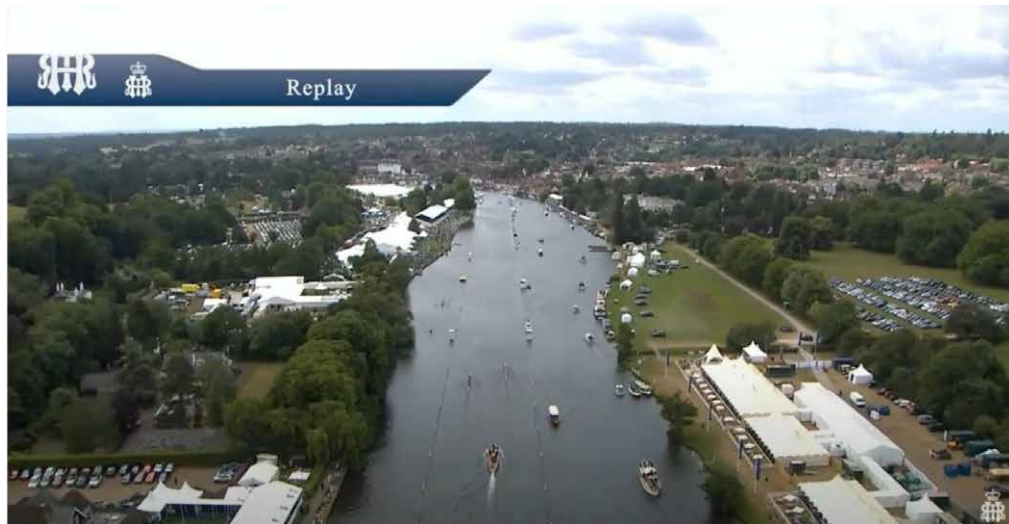
**Figure 3**

When the aircraft was about 250 m up-river from the pontoon, the aircraft's low voltage battery warning activated. The pilot responded by flying the aircraft back towards the pontoon to expedite its landing. However, when the aircraft was almost overhead the pontoon at a height of about 50 m, it stopped responding to the pilot's commands and started to rotate whilst also descending rapidly. The aircraft struck The Celtic Queen, which was now almost abeam the pontoon, before falling into the river. No persons were injured. One of the aircraft's batteries came to rest between the two passengers seated near the bow, which was about 2 m away from where the aircraft had struck the boat. The aircraft was not recovered from the river.

Image from the aircraft taken shortly before its loss of control

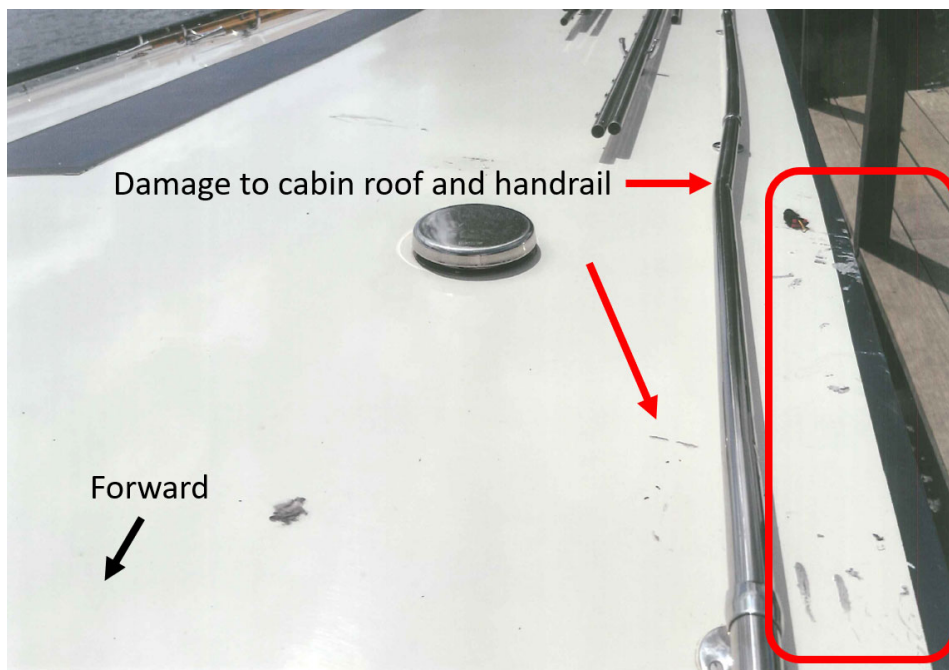
**Figure 5**

The aircraft had initially collided with the forward left side cabin roof causing deformation in a section of the stainless-steel handrail and damage to the surface of the roof (Figure 5). The aircraft then struck the left side of the cabin and adjacent gunwale, prior to it falling into the river and sinking. Composite material from the aircraft had been embedded into the wooden surface on the gunwale (Figure 6) and one of its batteries had detached from the aircraft and come to rest on the forward deck (Figure 7).

Damage to cabin roof and left side handrail

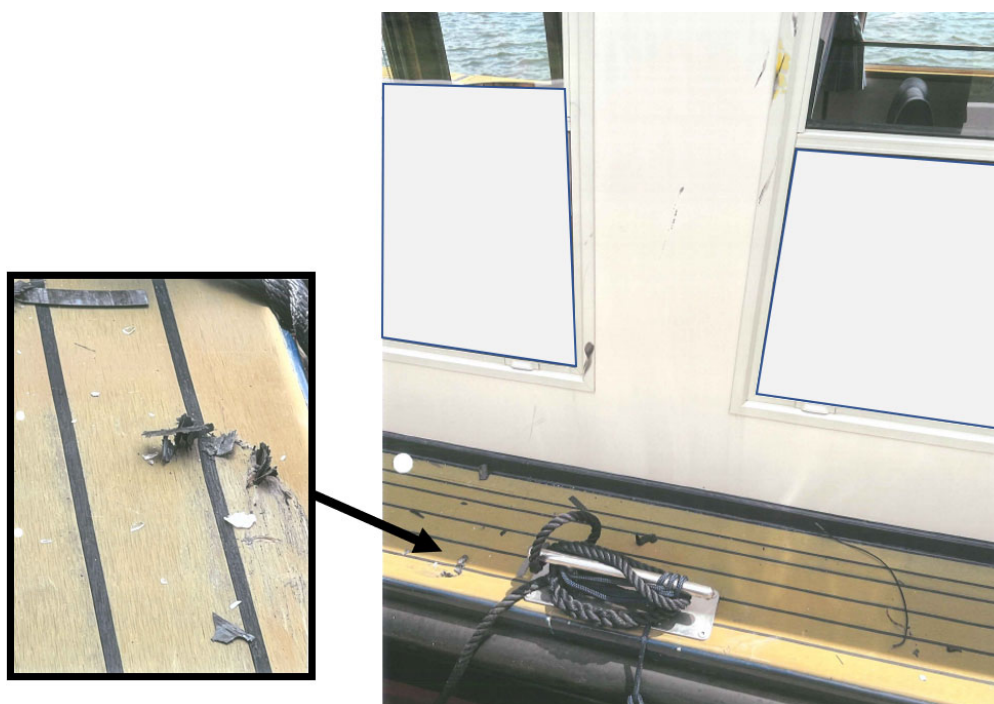
**Figure 6**

Damage to the cabin and gunwale

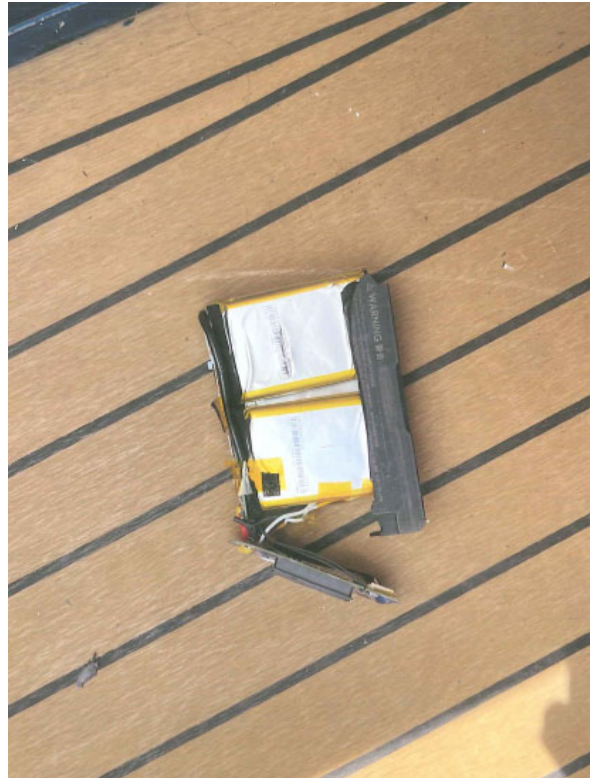
**Figure 7**

Aircraft battery on forward deck
