# ***AAIB Bulletin***

# ***1/2023***

## ACCIDENT

| <b>Aircraft Type and Registration:</b> | Freefly Systems Inc. Alta X | |

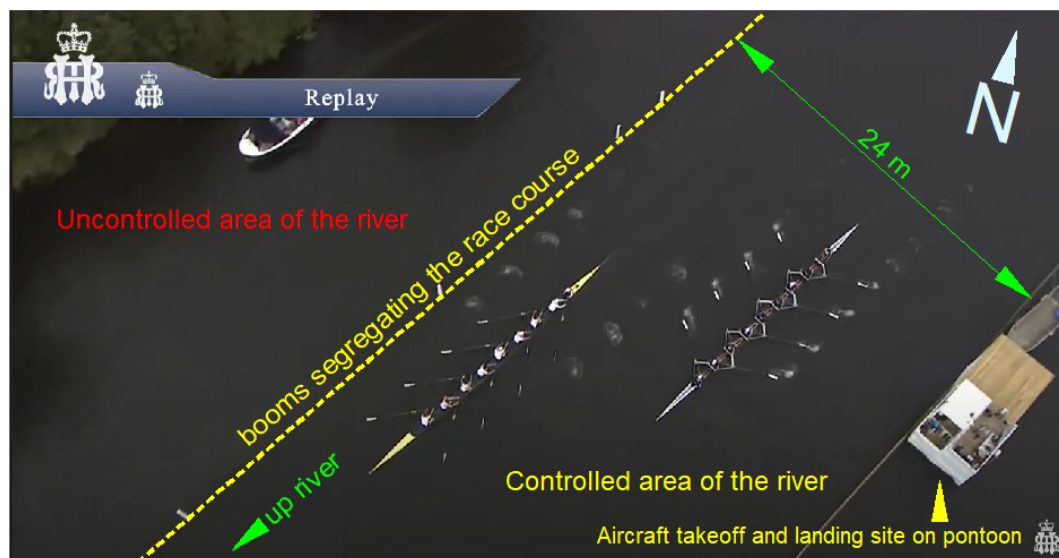
**Figure 1**

At 1120 hrs, the aircraft took off on its 21<sup>st</sup> flight of the day, which was to film race 35. The flight initially proceeded as normal, with the pilot flying the aircraft overhead two competing boats (Figure 1) at a height of about 50 m (164 ft agl). Operating on the uncontrolled side of the river were several privately operated boats. This included The Celtic Queen (Figure 2), which was travelling down-river. Onboard this boat were six people, of which two were seated near the bow of the boat.

Image taken from the aircraft's camera showing the takeoff and landing pontoon and the adjacent controlled/uncontrolled sides of the river

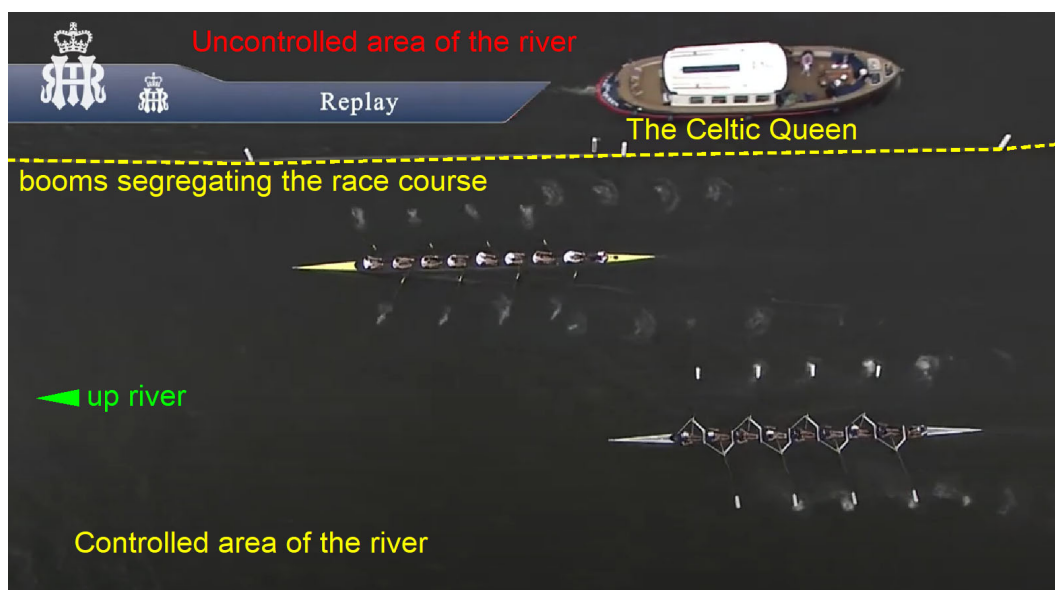
**Figure 2**

Image from the aircraft, with The Celtic Queen travelling down-river.

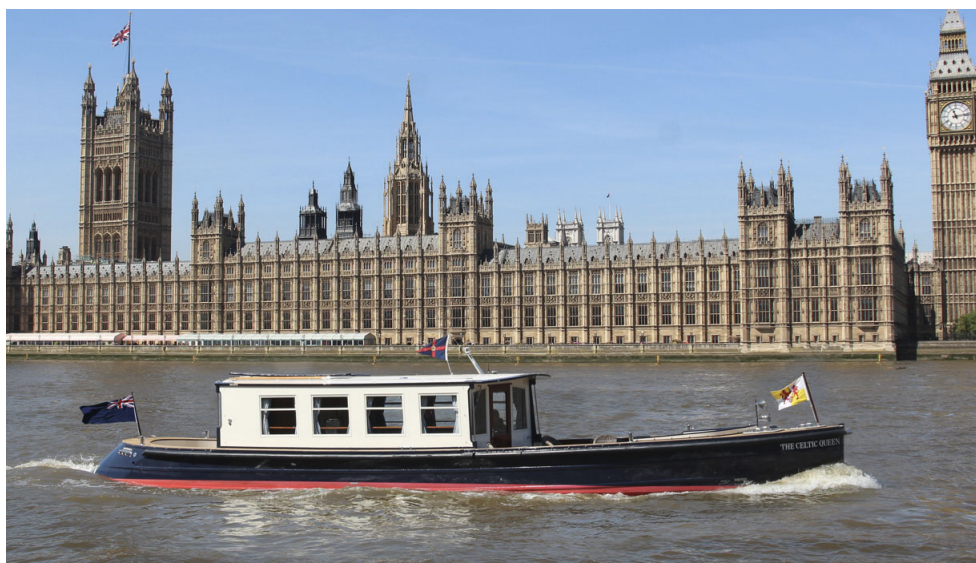
**Figure 4**

The Celtic Queen is a boat of approximately 20 m in length and 3 m wide (Figure 4), with a cabin of metal construction. At the bow and stern are seating areas for passengers.

The Celtic Queen (Photograph used with permission)

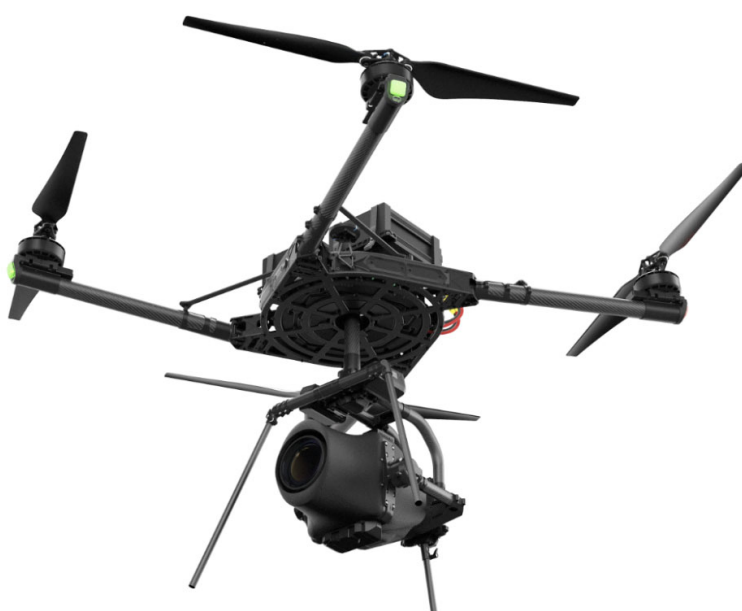
**Figure 8**

The Alta X (Figure 8) is an unmanned, electrically powered quadcopter with a maximum takeoff weight of 34.9 kg<sup>2</sup>. This type of aircraft relies upon its propulsion system for lift. The aircraft's rotors are 84 cm in length and, when the motor arms are extended for flight, the aircraft measures 2.28 m from rotor tip to rotor tip. During the accident flight the aircraft's takeoff weight was 28 kg, which included an underslung camera mounted on a gimbal.

Alta X (not the accident aircraft)
